# Hard Trails in Alaska

## Responding to ATV Impacts on the Last Frontier

## Trail Hardening System for Degraded Trails

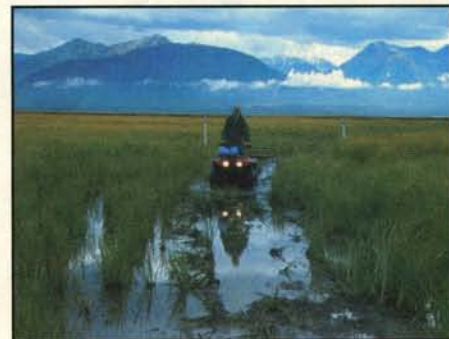
**An ATV rider confronts a degraded wetland trail segment.**

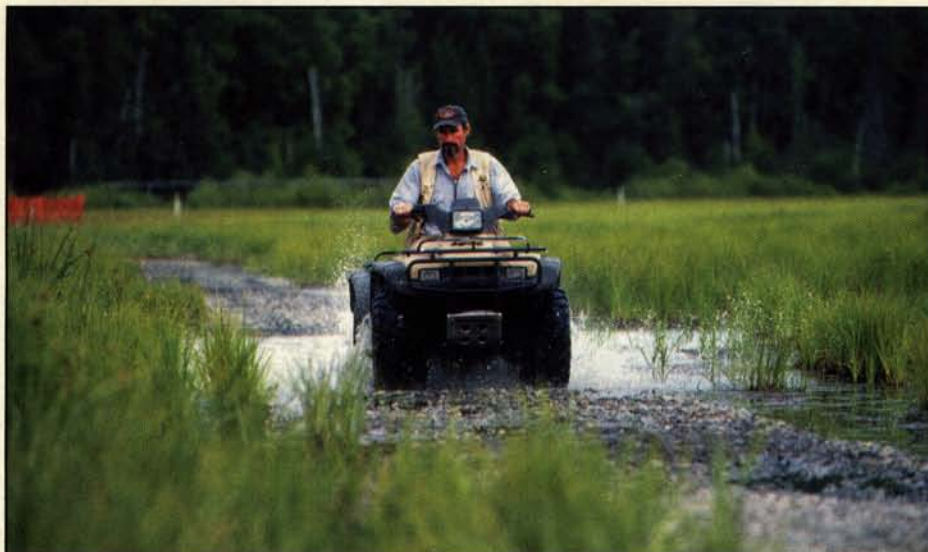
**Kevin Meyer, a specialist with the NPS Rivers and Trails Program traverses a newly installed section of hardened trail at the Palmer Hay Flats. Photo credit: Erik Hill, Anchorage Daily News**

Installation was a cooperative effort by the AK Dept of Fish & Game and the National Park Service Rivers Trails and Conservation Assistance Program. Crews laid the Geoblock units across an 800-foot stretch of the boggy trail, a main route into the refuge, in five days. An optimum laying pattern was tested and finally implemented to provide the best resistance to movement under wheel loading. To secure the mat system, adjacent units were fastened together with 3/4" screws and 120 lb tensile strength plastic cable ties.

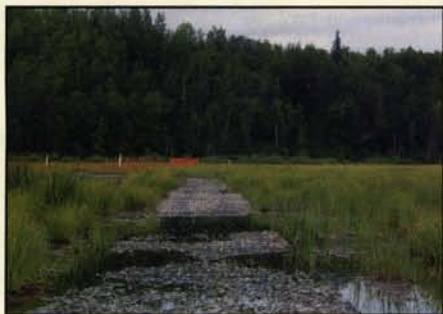
Gravel ballast is used at pond crossings.

Because the cost and accessibility of infill material was prohibitive at many similar locations, no infill was used on the trail except in areas where the units were applied underwater. In those wet areas, 3/4 - to 2-inch washed gravel was spread into the units' cells, adding weight to a system that otherwise would float when submerged in water. The stabilized area runs through two shallow ponds near the beginning of the trail - an area so wet it was typically crossed wearing hip boots.

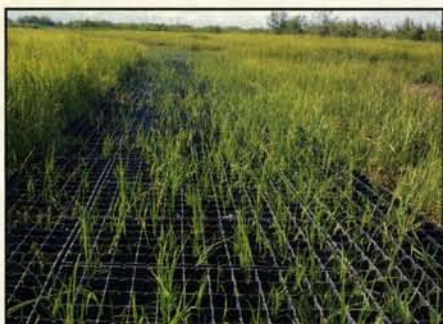
Open grid cell allows for vegetation re-growth.

The test material chosen for this site was the Presto Geoblock® system. The Geoblock units are an open-celled, light-weight plastic material, measuring 20-in by 40-in by 2-in. This porous system has been typically used with topsoil/vegetative infill for emergency and utility access lanes, auxiliary parking areas and trails. The interlocking units create a load-distribution system, designed to support heavy loads and protect the vegetative root zone within its cells. The open cells of the Geoblock system allow water to pass through, but keep the damaging tires of an all-terrain vehicle away from the ground and plants. The cells can also confine and stabilize aggregate infill in non-vegetated systems.
